MISSISSIPPI ENVIRONMENTAL GEOLOGY

David T. Dockery III and David E. Thompson

Mississippi Department of Environmental Quality
Office of Geology
Second Edition, 2019

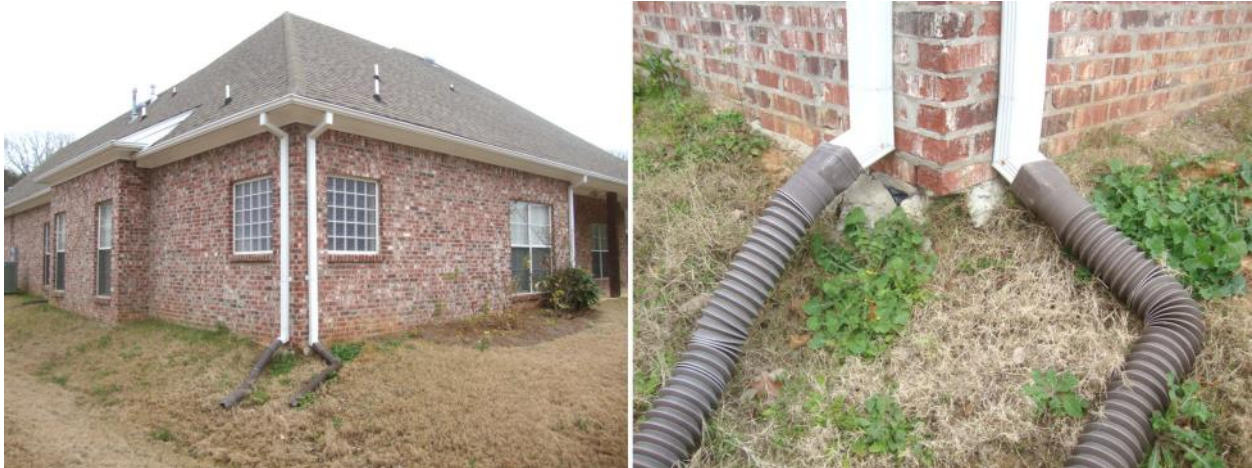
Figure 250. Left, a recently-built home in Madison County landscaped with the ground sloping away from the foundation and with downspout diverters that carry rainfall away from the foundation. Right, close-up view of the downspout diverters. Pictures (digital; Image 2320) were taken on February 6, 2013.

New Madison County Homes on Slabs. New homes with slab foundations on the Yazoo Clay in a recently-built subdivision in Madison County minimize water saturation around the foundation by sloping the land away from the house in all directions and by the use of downspout diverters to direct rain water away from the slab (**Figure 250**).

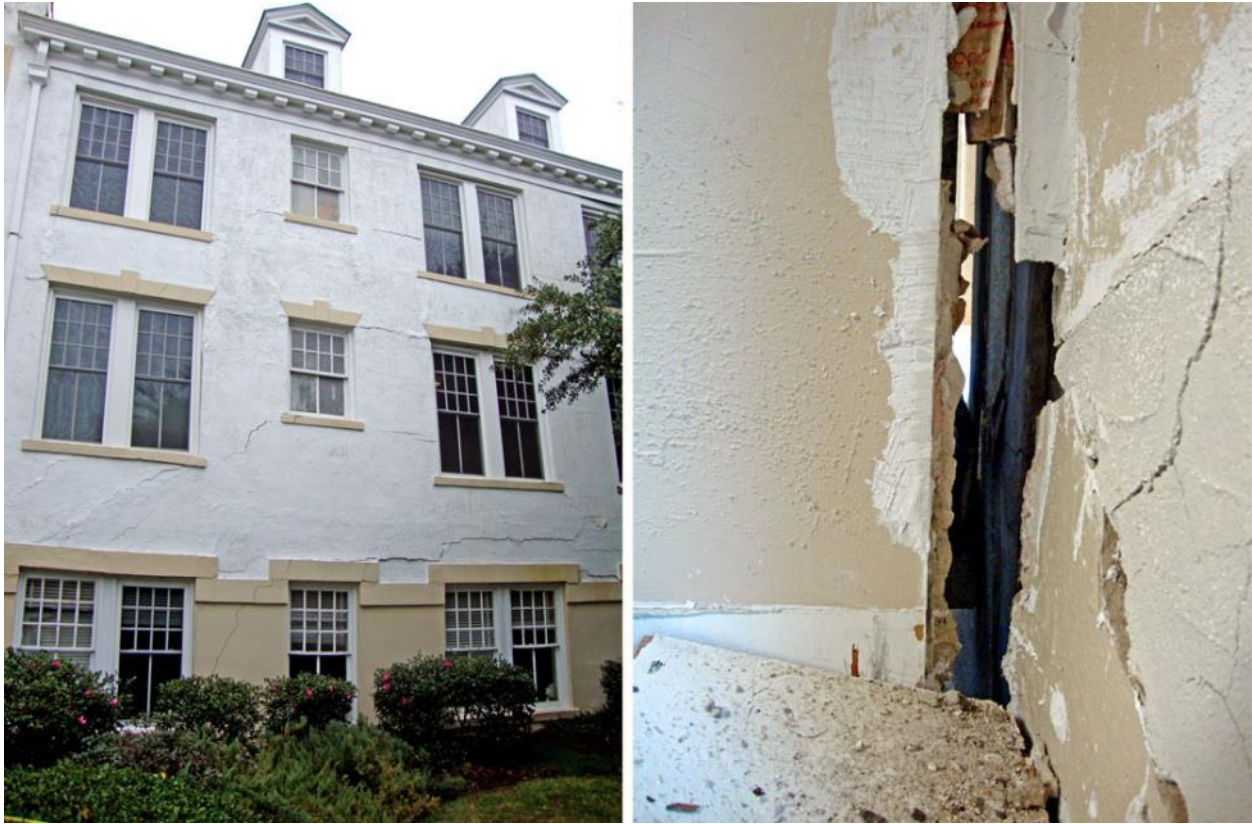
Figure 251. Bowed-out walls of FritzHugh Hall at Belhaven University in Jackson, Mississippi, after a water leak in a 6-inch fire line caused the Yazoo Clay to swell under the foundation, separating the exterior and interior walls. The damaged wing of the building was quickly evacuated of personnel, files, and equipment on December 15, 2011. Picture (digital; Image 2143) was taken on December 16, 2011.

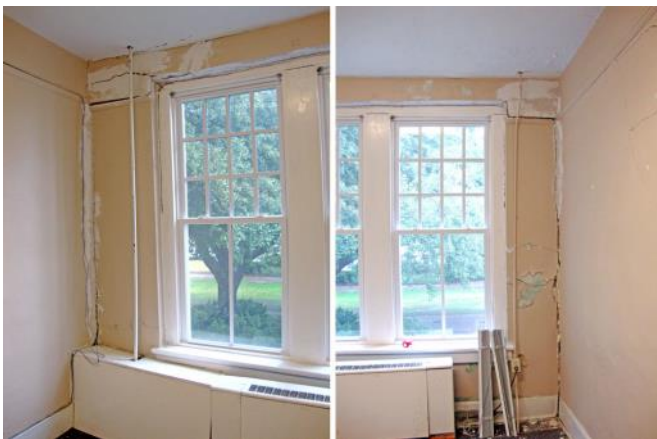
Figure 252. Room 214, Office of the Assistant to the President in the east wing of FitzHugh Hall at Belhaven University in Jackson, Mississippi, showing cracks at wall joints, the floor, and at windows. Pictures (digital; Image 2144) were taken on December 16, 2011.

The staff of Fitzhugh Hall's east wing made a hurried exit, moving their files and equipment to other spaces on campus. By the next day, the east wing was abandoned. New locks were placed on entrances to the east wing to keep all the maintenance crews at locked out. **Figures 251-253** show the damaged walls of the east wing on December 16, 2011, a day after the hall was evacuated. On June 29, 2012, with a little help from two

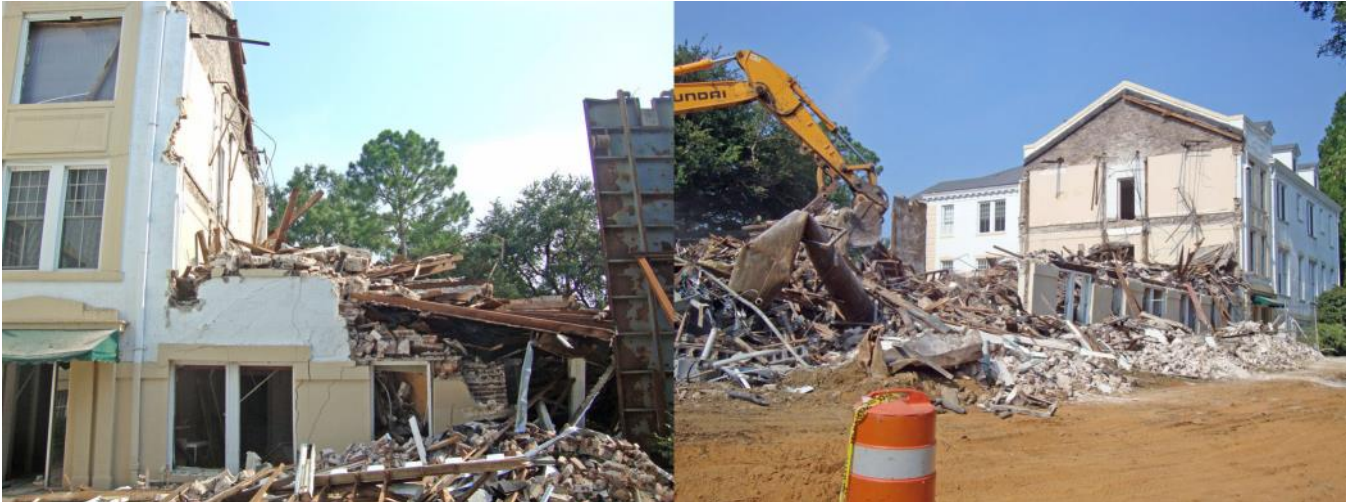
Figure 254. Demolition of the East Wing of Fitzhugh Hall at Belhaven University after the exterior south wall buckled. View of south wall is at left with the original cracks visible in what remains of the first floor; view of north wall is at right. Pictures (digital; Image 2250) were taken on June 30, 2012.

trackhoes, the east-wing walls "came tumbling down." **Figure 254** shows the demolished wing the day after, as the trackhoes were loading debris to be hauled to a rubbish landfill.

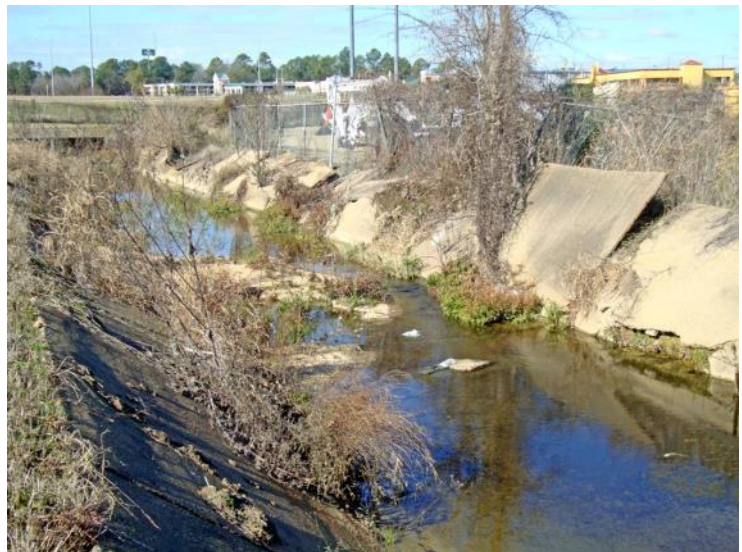
Figure 255. Heaving of the Yazoo Clay beneath a concrete drainage ditch at the intersection of Interstate 20 and Ellis Avenue in Jackson, Mississippi, lifted and shattered the bottom concrete panel of the ditch and lifted the side panels out of place. Picture (digital; Image 2146) was taken on January 7, 2012.

Figure 255 shows the concrete panels of a drainage ditch on the southeast corner of the intersection of Interstate 20 and Ellis Avenue at Jackson, Mississippi. Heaving in the Yazoo Clay has lifted and cracked the bottom concrete panels of the ditch and has lifted the side panels out of place.

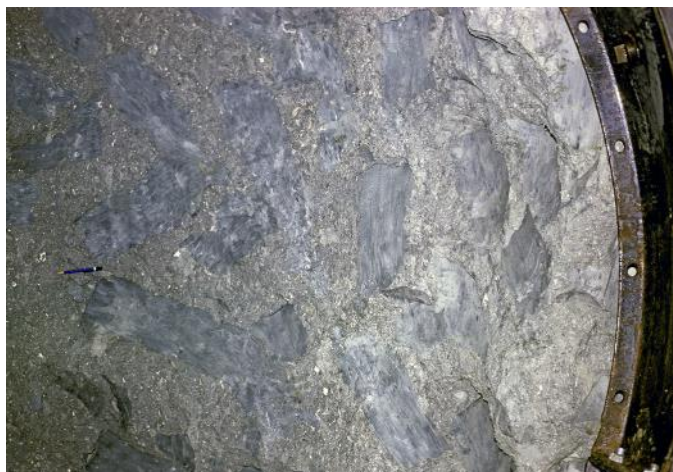
Figure 260. Moodys Branch Formation speckled with white fossil shells in the excavation of a sewer tunnel under Jackson, Mississippi. Steel tunnel siding at right and pencil for scale at left. Picture (slide 154-10; Image 173) was taken in September of 1973.

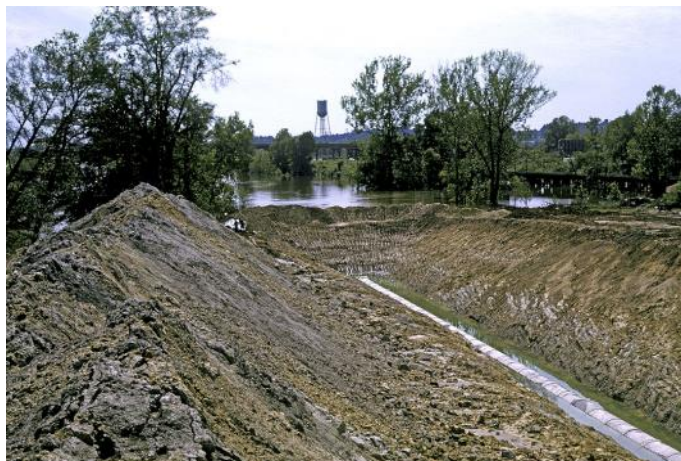
Figure 261. Excavation of the Moodys Branch Formation and Yazoo Clay for the City of Jackson 66-inch sewer line across Town Creek. The excavation material served as a dike to hold back flood waters of the Pearl River from the excavation site. Picture (slide 156-2; Image 525) was taken in May of 1974.

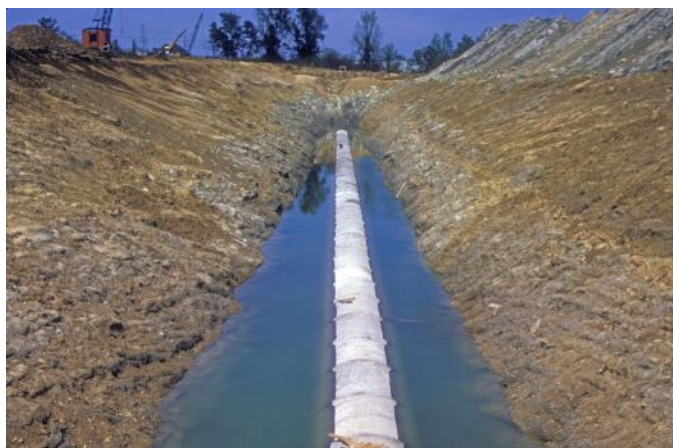
Figure 262. Length-wise view of construction of Jackson's 66-inch sewer mainline in south Jackson just north of Town Creek. The contact between the unweathered (below) and weathered Yazoo Clay can be seen in cut at right. Spoil piles from the cut are at the top right. Picture (slide 156-7; Image 1943) was taken in May of 1974 during flood stage on the Pearl River.

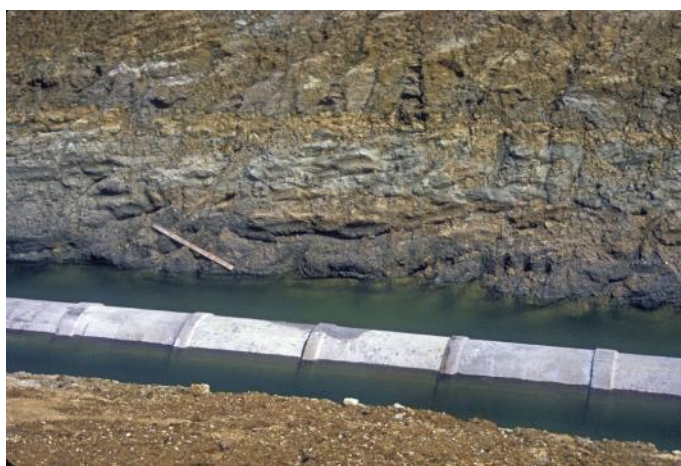
Figure 263. Side view of construction of Jackson's 66-inch sewer mainline in south Jackson just north of Town Creek. Picture (slide 156-8; Image 1944) was taken in May of 1974 during flood state on the Pearl River.

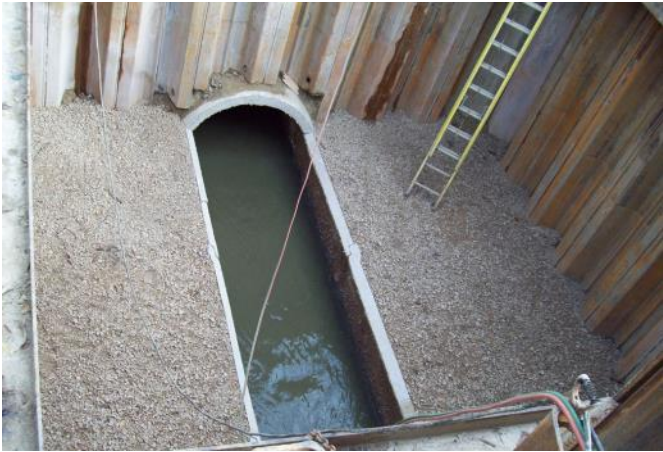
Figure 264. Box cut in the Jackson 66-inch sewer line near the east end of Rankin Street adjacent to Town Creek. The line was cut at 10 o'clock and 2 o'clock to insert a liner that will protect the concrete pipe from the corrosive effects of sewer gas. The picture (digital; Image 1109) was taken by James Starnes on December 5, 2008, a time of normal sewage flow and of low water on the Pearl River.

acid then eats away at the concrete or metal sewer pipe. To repair the sewer line, the line had to be excavated and cut for the installation of a plastic interior liner as shown in **figures 264-266**. Sewage had to be pumped from one box cut across Town Creek to another box cut to facilitate work on the damaged section (**Figure 267**).

A River Runs Through It: The low and high flows in Jackson's interceptor line as seen in figures 264 and 265 and in the Pearl River gage height in Figure 258 indicate that the river and interceptor line are hydrologically connected. In Figure 254, the interceptor line is less than half full at a river stage below 10 feet. In Figure 255, the water level in the shaft leading to the line is at the level of the river flood stage above 30 feet. This connection with river water may be due to leakage in the joints of the interceptor line from sewer gas corrosion or from open manholes at low elevations in the Jackson sewer system. Either way the sewage flow to the Savannah Treatment plant is still coupled with the flood stage of the

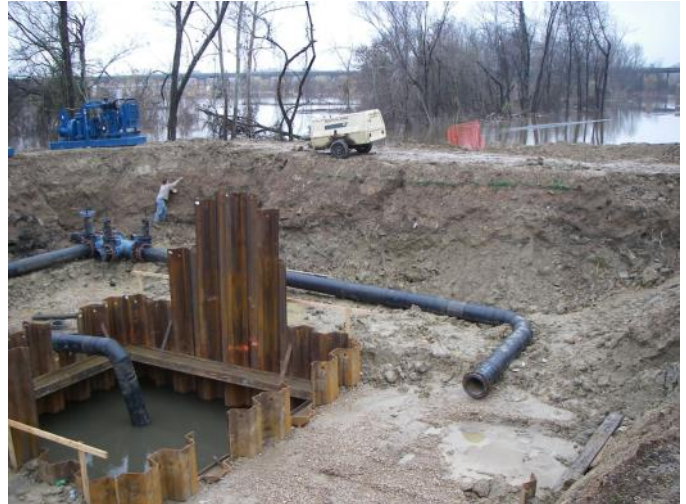
Figure 265. Backed up sewage is rising in the box cut, while flood waters of the Pearl River are rising outside the protective levee around the construction site. Between the rising sewage and rising river, James Starnes is collecting fossil seashells excavated from the Moodys Branch Formation. The picture (digital; Image 1110) was taken on December 17, 2008.

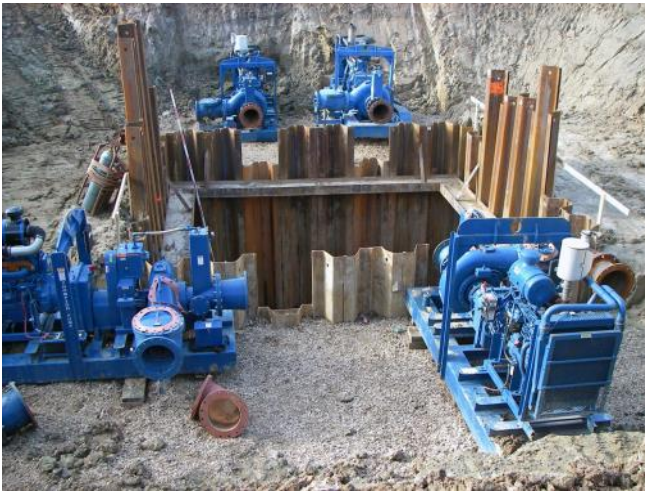
Figure 266. Pumps in place to pump sewage from the box cut, around the section of sewer main crossing Town Creek, to another box cut on the other side of the creek. Picture (digital; Image 1947) was taken on December 6, 2008.

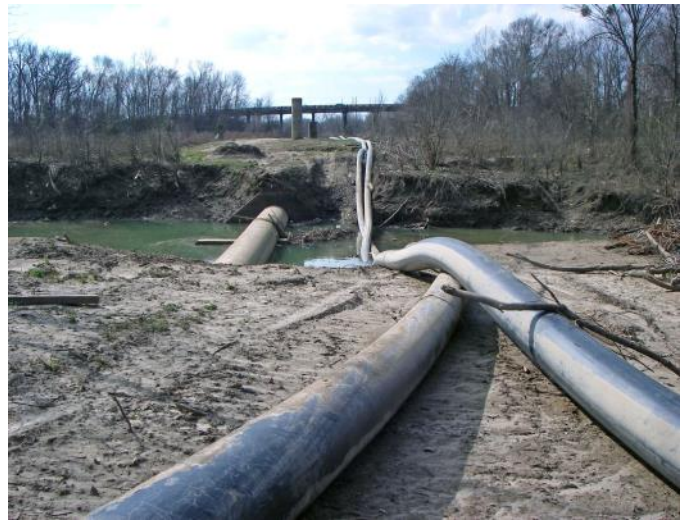
Figure 267. Plastic pipes carry sewage around a leaking section of the 66-inch concrete sewer main crossing Town Creek so that repairs can be made and a plastic liner can be inserted. The sewer main can be seen crossing Town Creek in the distance as can the elevated manholes. Picture (digital; Image 1948) was taken on January 27, 2009.

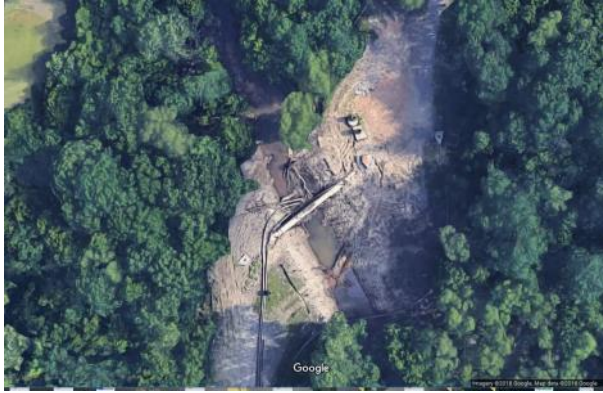
Figure 270. Jackson sewer interceptor line crossing Eubanks Creek as taken from Google Maps satellite image 2018.

Figures 270 and 271 show the interceptor line exposed where it crosses Eubanks Creek and Town Creek. At the time these satellite images were made, the line was not flooded on Eubanks Creek but was flooded on Town Creek. Manhole covers on the interceptor line are elevated as can be seen in the shadow casted by the one in Figure 261.

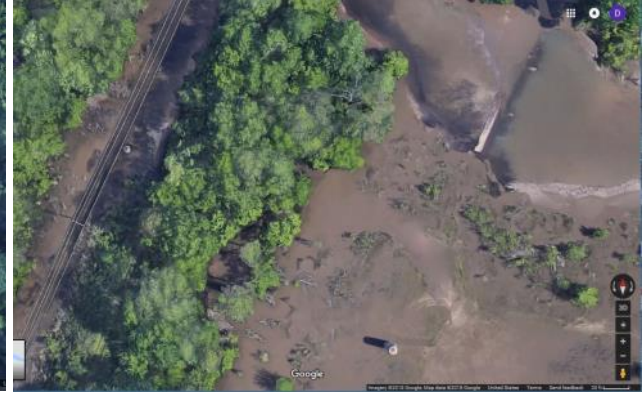
Figure 271. Jackson sewer interceptor line crossing Town Creek in upper right partially obscured by Pearl River flood water. A raised manhole and shadow can be seen at bottom just right of center.

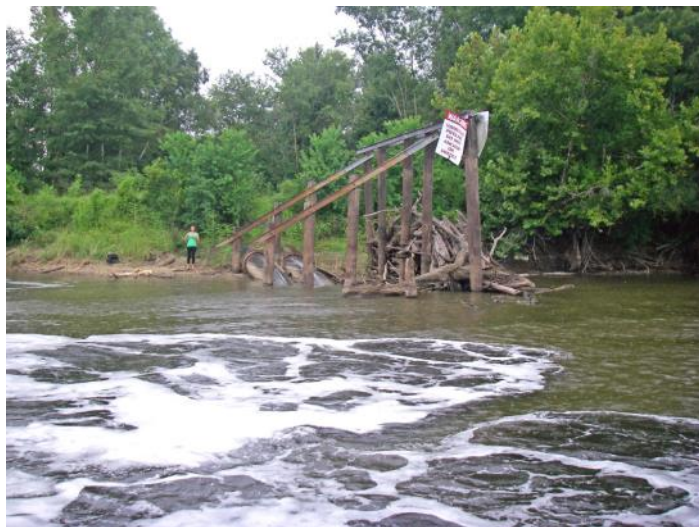
Figure 273. White foam welling up in the Pearl River in Pearl River County, Mississippi, at the point of a “black liquor” release from pipes on the opposite bank next to a Louisiana reporter. The release from a Louisiana paper plant depleted oxygen in the river and killed much of the river’s aquatic life. Picture (digital; Image 1955) was taken by Emily Cotton on August 14, 2011.

that extended from Highway 26 near Poplarville south to I-59 near Nicholson (**figures 273-276**).

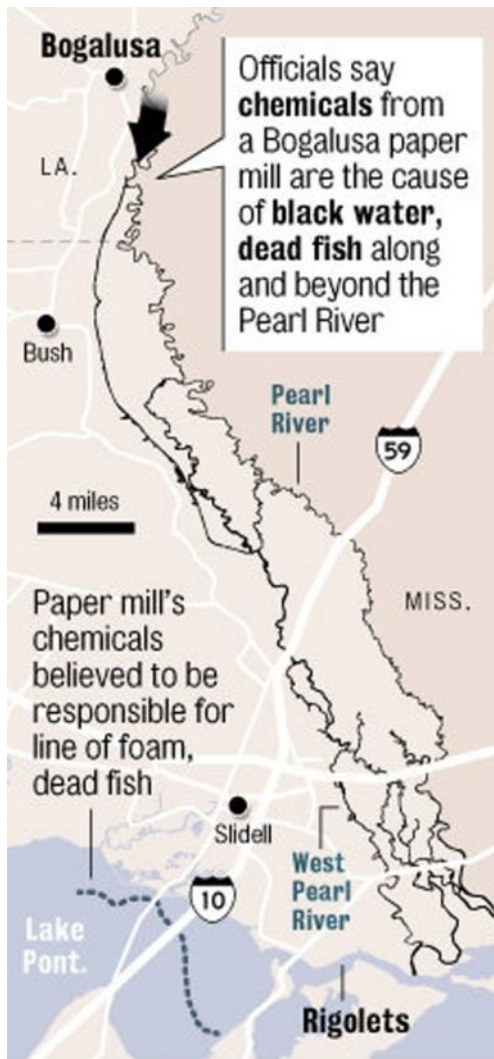
Figure 277. Extent of the fish kill in the lower Pearl River due to a release of "black liquor" by a Louisiana paper plant. Image 1954, from the Times-Picayune.

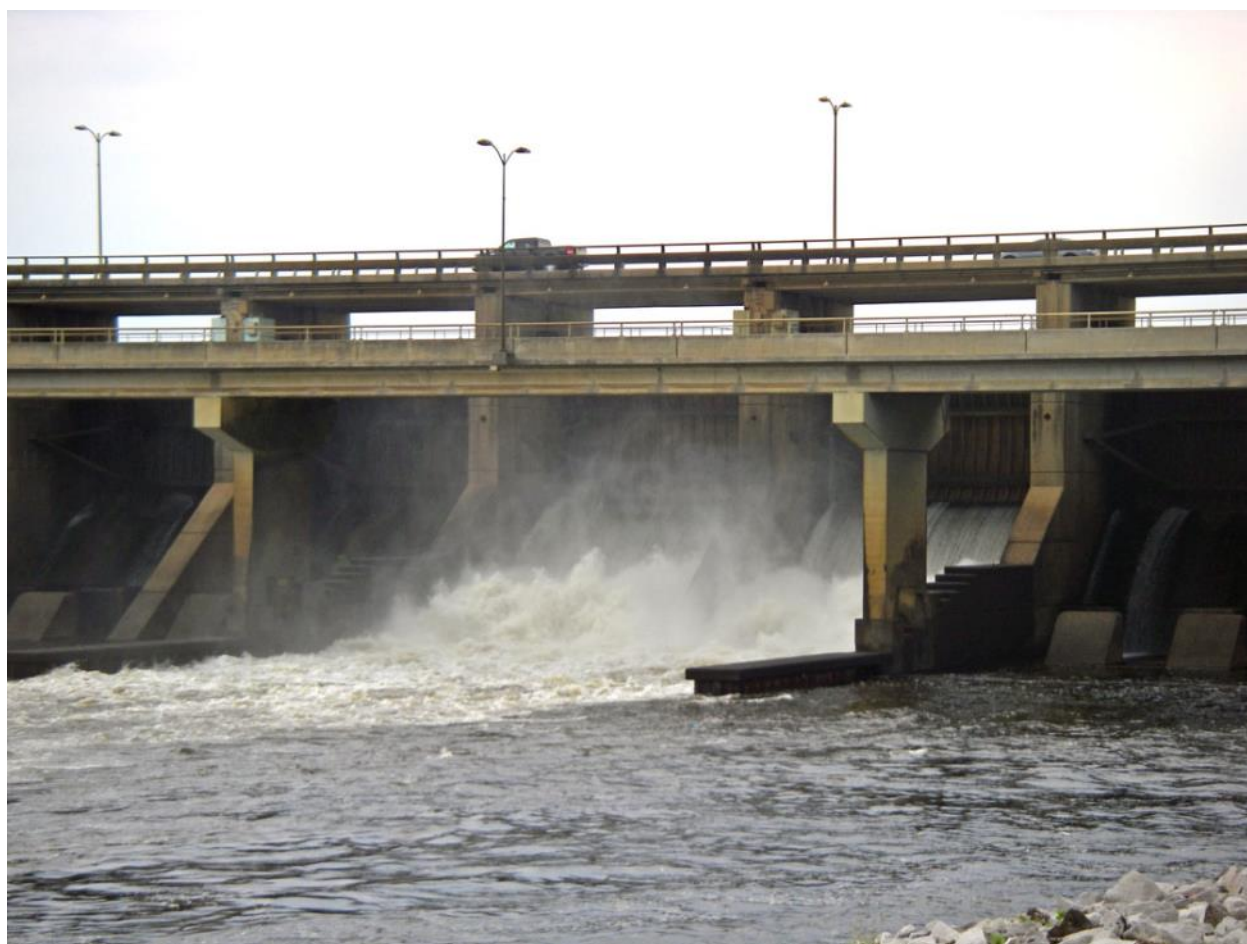
Figure 280. Ross Barnett Reservoir discharge is increased from 255 cubic feet per second (cfs) to 2,145 cfs on August 17, releasing an additional 2 billion gallons of water over a two-day period to flush out pollution downstream. Picture (digital, Image 1979) was taken by Barry McMaster on August 17, 2011.

dilute the pollution downstream. On August 17, the Pearl River Water Supply District agreed to release an extra 2 billion gallons of water (**Figure 280**) to help purge the river system (an increase in discharge from 255 cubic feet per second [cfs] to 2,145 cfs over a two-day period). That release lowered the reservoir level by three inches (0.25 feet). The travel time for the water to reach the polluted stretch in Pearl River County (and extending to the Gulf of Mexico) took about three days. On August 22 water from the reservoir release increased the river level in Pearl River County by 2.8 feet. Helping the reservoir release was a pulse of freshwater produced by severe thunder storms in central Mississippi on Thursday, August 18. It would be about a month, on September 13, before MDEQ declared the Pearl River between Highway 26 and Interstate 59 to be safe for water contact and fish consumption.

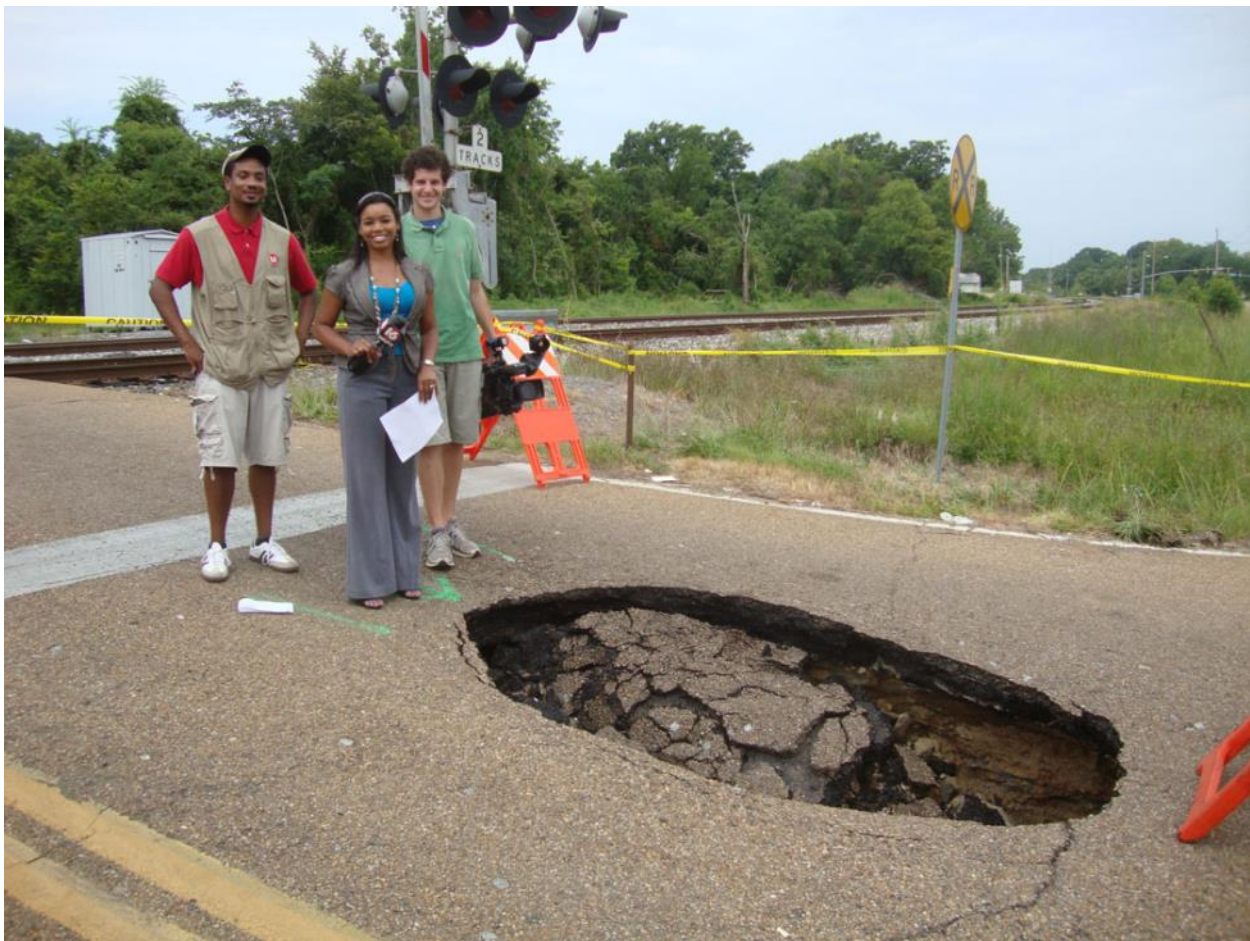
Figure 281. Tammy Estwick and the WAPT News crew at a road collapse above a leaking sewer line under Longino Street between the railroad tracks and West Fortification Street in Jackson, Mississippi. Picture (digital, Image 2264) was taken on July 6, 2012.

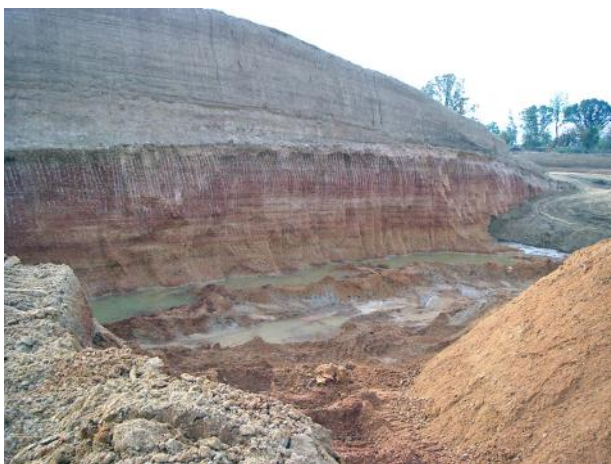
Figure 282. Highwall at the Hammett Gravel Company Zeiglerville pit in Yazoo county, where 25 feet of loess overlies 25 feet of gravel. Picture (digital; Image 950) was taken on November 9, 2007.

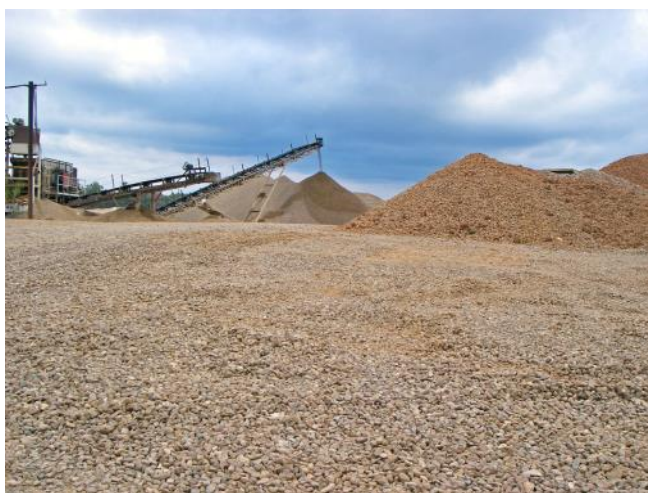
Figure 284. Gravel washing operation located at the Hammett Gravel Company Zieglerville pit in Yazoo County. Gravel is transported to this site by a conveyor belt from the active mine, which is more than a mile away. Picture (digital; Image 1973) was taken on November 9, 2007.

Gravel-Wash Operations. Gravel-wash operations separate gravel from finer sediments and sort the gravel by size in shakers containing sieves of different sizes (**Figure 284**). Gravel is sorted into pea-size, pebble-size, and over-sized. The pea-sized and pebble-sized gravel is used in concrete and for gravel driveways. The over-sized gravel is used in drainage systems for landfills or is crushed into angular fragments which are used as aggregate in asphalt for road surfaces. Fine sediments, consisting largely of sand, from the washing operation are drained into a pond or lake dredged for that purpose and do not leave the site. When the pond is full, the sand is dredged out and stockpiled for future use. Sand that is not sold can be used as fill materi-

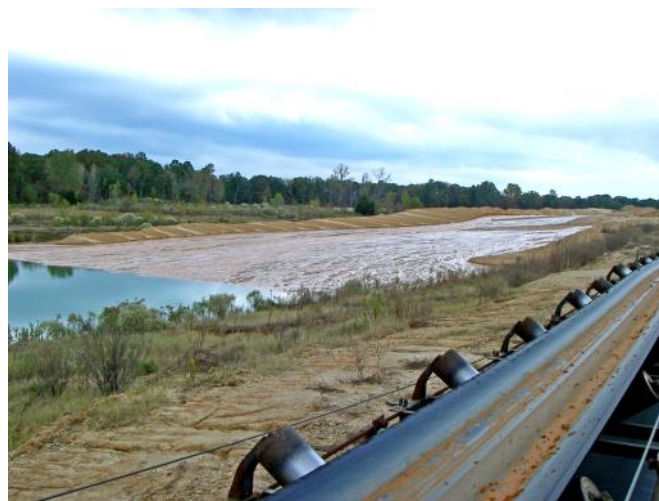
Figure 285. Sand draining from gravel wash operation forms a delta at the head of a containment lake. The conveyor belt that transports the gravel to the gravel wash is at the lower right. Picture (digital; Image 1972) was taken on November 9, 2007.

al when the gravel pit is reclaimed (**figures 285-286**).

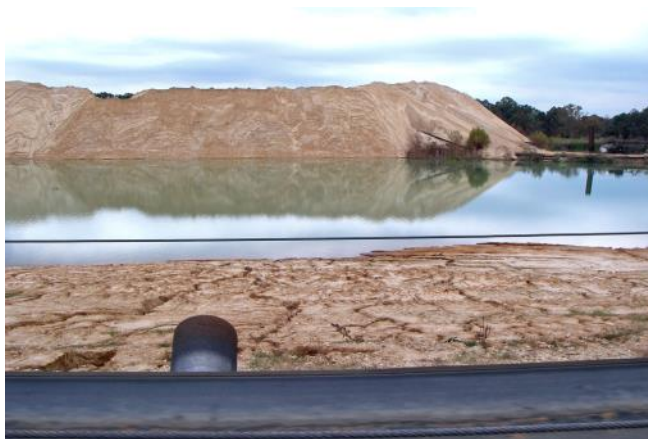
Figure 286. Stockpiles of sand dredged from the containment lake at the Hammond Gravel Company Zieglerville pit in Yazoo County. Picture (digital; Image 1974) was taken on November 9, 2007.

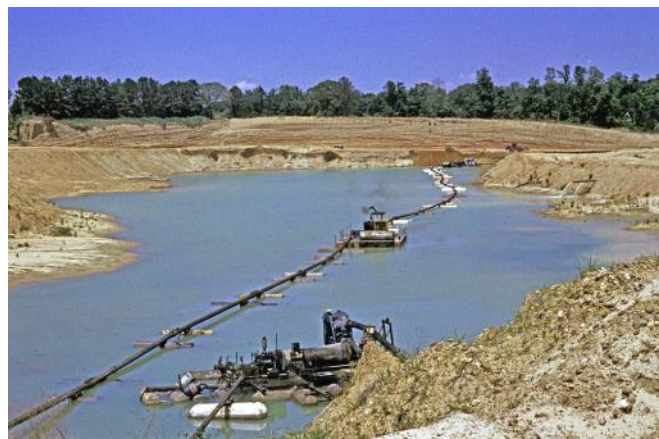
Figure 287. Gravel dredge at Hammett Gravel Company pit in Yazoo County. Picture (slide 375-28; Image 33) was taken on May 5, 2004.

Mine Dewatering. There are two methods for mining gravel layers that lie beneath the water table. One method is to dredge the gravel from the flooded pit floor using a pump and a suction pipe that delivers a slurry of gravel, sand, and water to the mine operation (**Figure 287**). The second method involves dewatering the mine site. This is accomplished by drilling water wells and pumping down the ground-water table until it is below the gravel deposit.

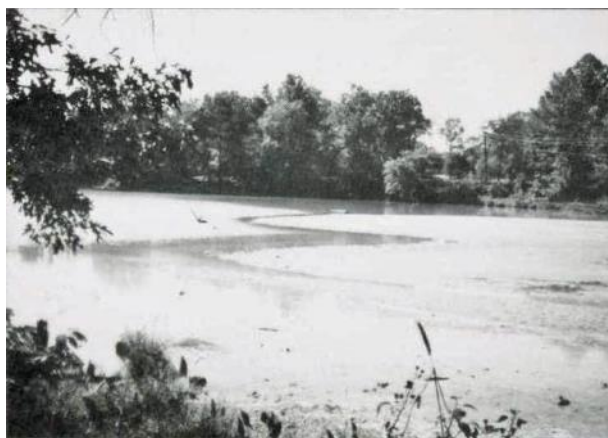
Figure 288. Stream delta formed at the head of the subdivision lake. Picture (scanned negative; Image 1980) from Ovanki, 1996, p. 46.

In 1991, construction began on a subdivision within the drainage basin upstream from the lake. After construction began, residents around the lake noticed an increase in the sediment content of the lake water. A sediment delta was rapidly forming at the head of the lake where the stream entered (**Figure 288**).

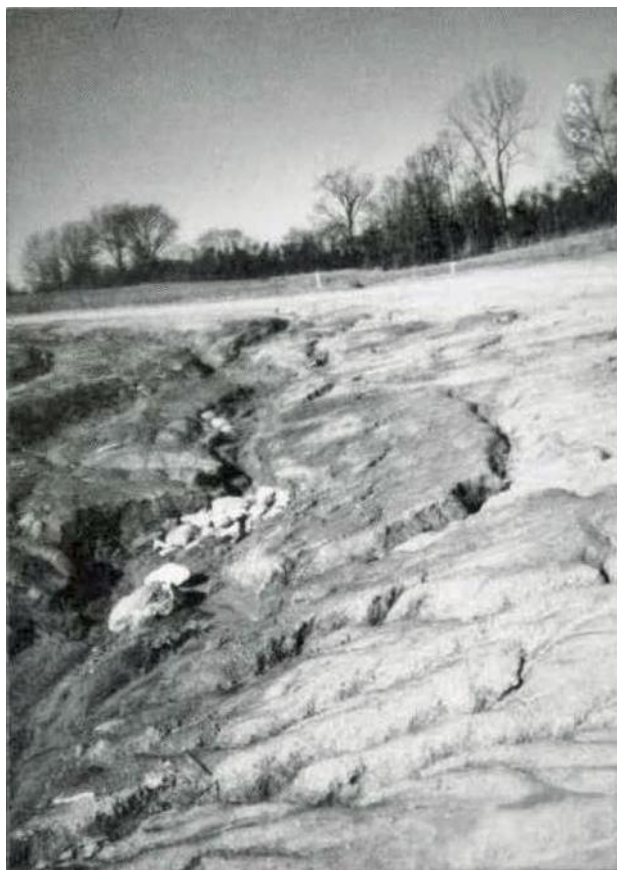
Figure 289. Construction site showing extensive soil erosion due to rain runoff. Picture (scanned negative; Image 1981) from Ovanki, 1966, p. 47.

The Office of Geology was asked to identify the source or sources of the sediment pollution as well as the amount of sediment from each source. This required sampling the sediment column in the lake bed and strata from specific localities within the drainage basin (**Figure 289**). Lake bed sediment would then need to be correlated with probable sources and with known historical events since the lake was constructed. As there were no mineralogical differences within the drainage basin, sediment sources were correlated with those of the lake bed by grain size differences.

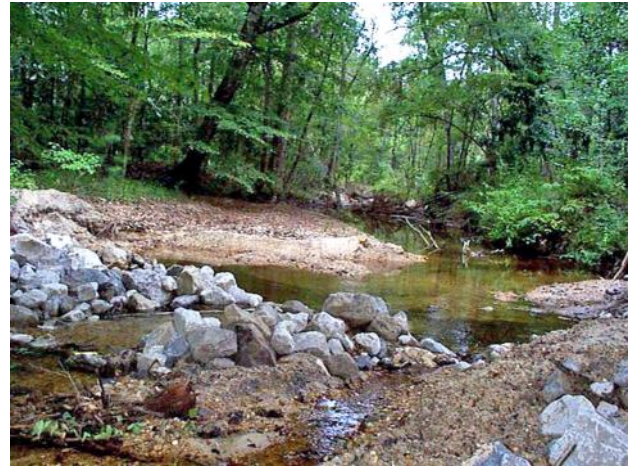
Figure 297. Rip-rap barrier placed across a tributary of the Homochitto River in the Homochitto National Forest to prevent headcutting erosion. Picture (digital; Image 2019) was taken by Carol Hardy.

(**Figure 297**) and high-price fixes such as reinforced concrete weirs (**Figure 298**). The following discussion of the Bayou Pierre, Homochitto, Amite, and Buttahatchee rivers is taken from Carol Hardy's PowerPoint thesis defense.

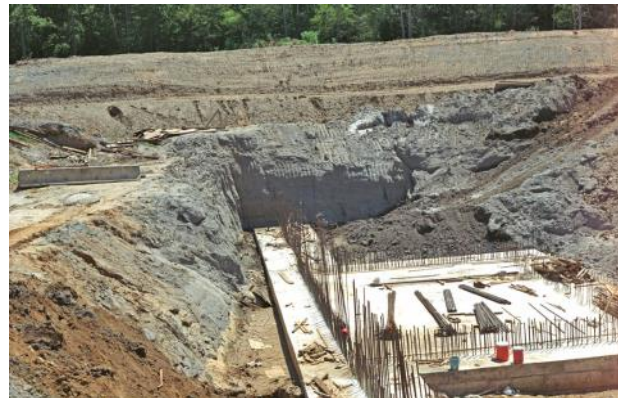
Figure 298. Construction of a reinforced concrete weir across Little Tallahatchie River southwest of Dumas in Tippah County, Mississippi. Picture (color negative 617-3, DVD 57; Image 2030) was taken on August 9, 2007.

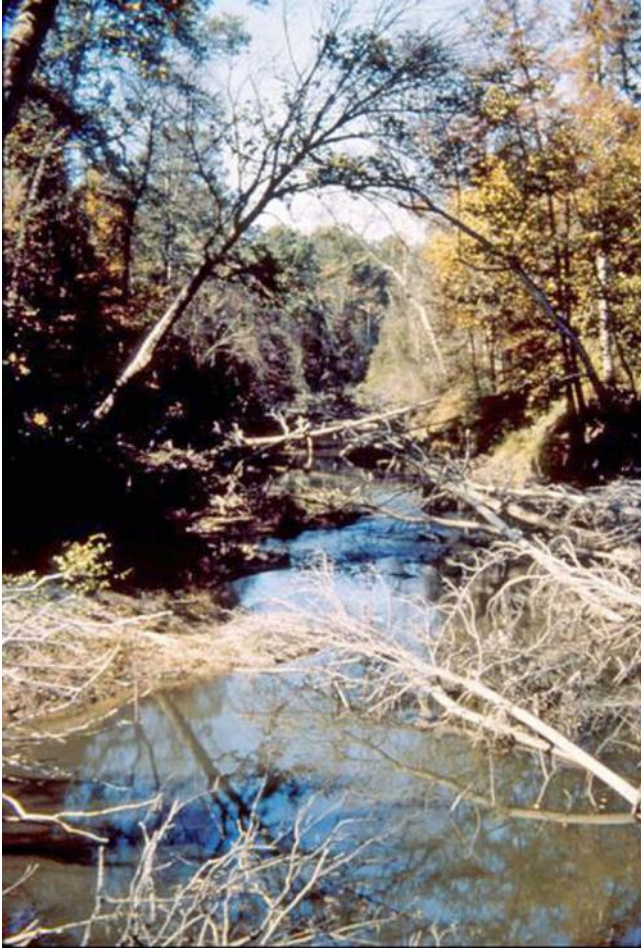
Figure 299. Bayou Pierre at Smyrna in Copiah County in 1983 before headcutting. Picture (slide; Image 2022) was taken by Paul Hartfield in 1983.

Bayou Pierre. The Bayou Pierre River has experienced active headcutting due to channelization work on the Mississippi River following the 1937 flood. Freshwater mussel collection trips from 1980 to 1983 found 12 species near Smyrna in Copiah County (Figure 299). By 1985, a knickpoint had reached the area (Figure 301), migrating upstream at a rate of 560 feet per year (Patrick et al., 1991). Repeated trips since 1985 have found no living mussel in the area (Figure 302). Figure 300 shows a bridge collapse over the Bayou Pierre River in Claiborne County due to headcutting erosion. Heitmuller et al., 2017, estimated that the Bayou Pierre knickpoint could compromise the Highway 28 bridge by the year 2028 (Figure 303).

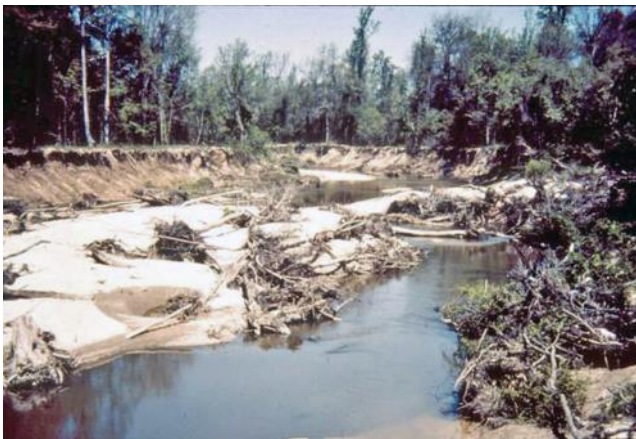
Figure 301. Bayou Pierre at Smyrna in Copiah County in 1985 after headcutting (same location as in Figure 260). Picture (slide; Image 2023) was taken by Paul Hartfield in 1985.

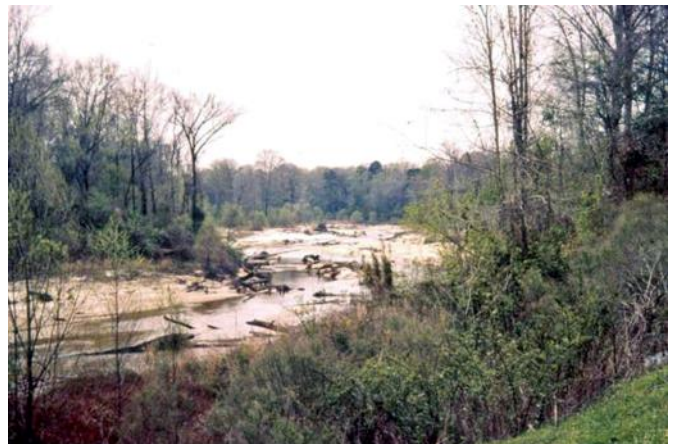
Figure 302. Bayou Pierre at Smyrna in Copiah County in 1995 beginning to stabilize after headcutting (same location as figures 260 and 262). Picture (slide; Image 2024) was taken by Paul Hartfield in 1995.

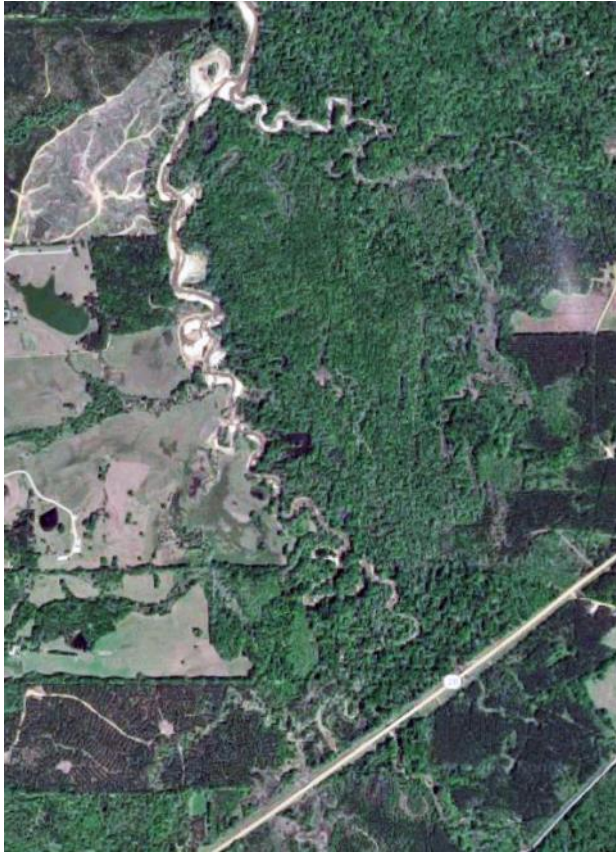
Figure 303. Aerial image (2017) of knickpoints heading upstream on Bayou Pierre (center) and a tributary (upper right) toward Highway 28 in Copiah County west of Hazlehurst, Mississippi. The channel is wide and sandy downstream from the knickpoints (at top of image) and narrow with tree-covered banks upstream of the knickpoint. Image 2525.

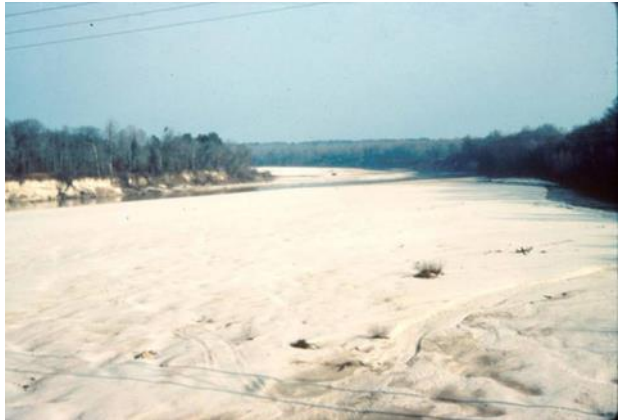
Figure 304. After headcutting dropped the channel 5.4 meters, the Homochitto River channel at low water is now filled with sand and is 0.4 to 0.8 kilometers wide. Picture (slide; Image 2032) was taken by Paul Hartfield.

Homochitto River. The lower portion of the Homochitto River was channelized between 1938 and 1940. Active headcutting has progressed steadily up the river and is currently affecting the headwater reaches (Patrick et al., 1993). In 1940, a stretch of the Homochitto some 40 miles from the river's mouth had a low channel width of 29 meters and average depth of 1.2 meters. In 1978, that same stretch has a low water channel width of 100 meters and an average depth of 3.0 meters (Figure 304). The river channel has dropped an estimated 5.4 meters since the time of its channelization. The channel is now sand-filled and is 0.4 to 0.8 kilometers wide. Between 1945 and 1974 at least 8 bridges have been lost due to river channel instability, costing some \$10 million. Freshwater mussel surveys in the 1980s found only 8 living species. Those in the 1990s found only 4 living species.

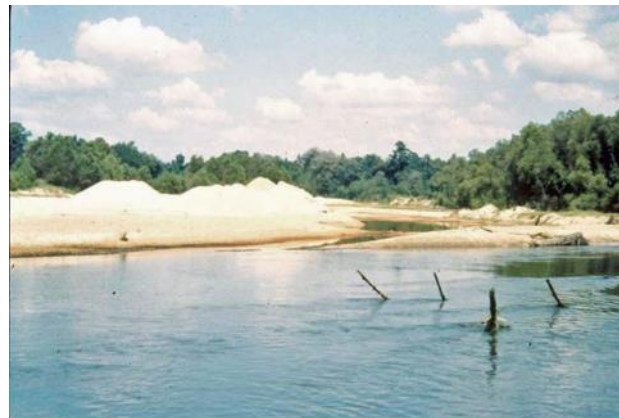
Figure 305. Gravel mining on Amite River point bars in Louisiana. Picture (slide; Image 2033) was taken by Paul Hartfield.

Amite River. The Amite River drains portions of southwestern Mississippi and southeastern Louisiana before ending in Lake Maurepas (**figures 305-310**). Active and abandoned gravel mines occur along a 48 kilometer reach of the river in Louisiana. This reach is mined at estimated rate of 140 acres per year. In the 1980s, 32 mussel species were found in surveys of the river (Vidrina, 1985). In the 1990s, headcutting activities had traveled into the headwater region and only 12 mussel species were found in reaches above the mines (Hartfield, 1992).

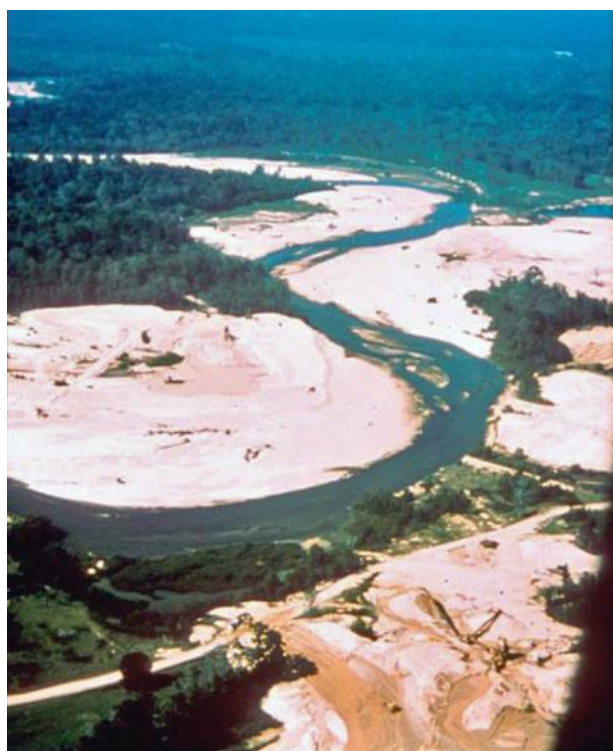
Figure 307. Areal view of gravel mines on Amite River point bars in Louisiana. Picture (slide; Image 2035) from Paul Hartfield.

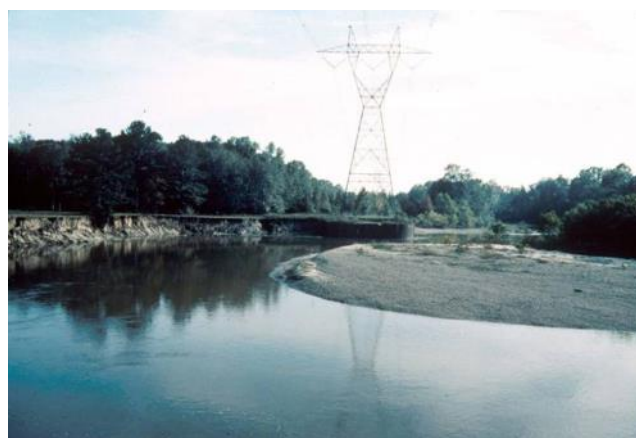
Figure 308. Amite River in Louisiana near the Mississippi line where a pylon base for a power line was captured by the headcutting of the stream channel. Picture (slide; Image 2036) was taken by Paul Hartfield.

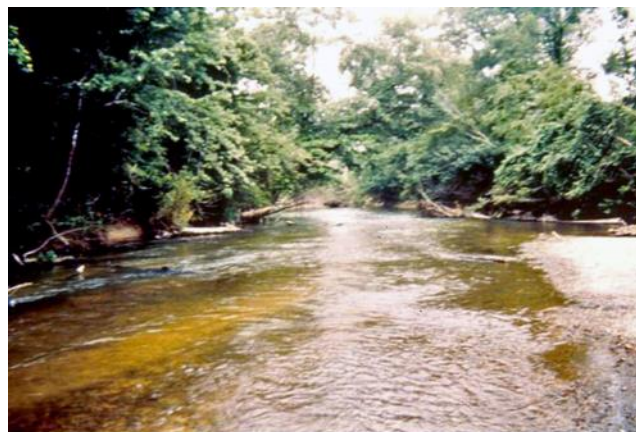
Figure 309. Amite River in Louisiana near the Mississippi line in 1984 in its natural channel before headcutting. Picture (slide; Image 2037) was taken by Paul Hartfield in 1984.

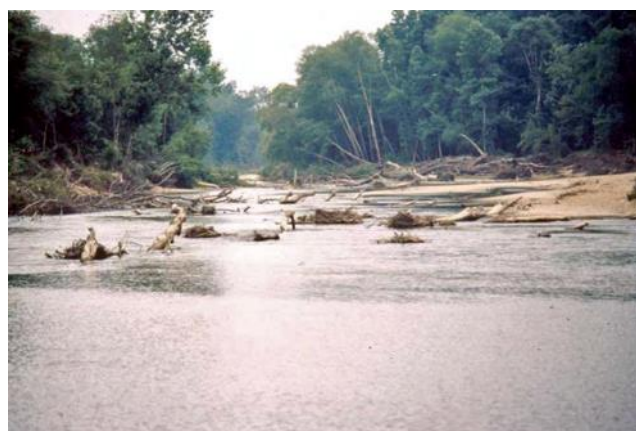
Figure 310. Amite River in Louisiana near the Mississippi line in 1988 at the same spot as in Figure 272 after being degraded by headcutting. Picture (slide; Image 2031) was taken by Paul Hartfield in 1988.

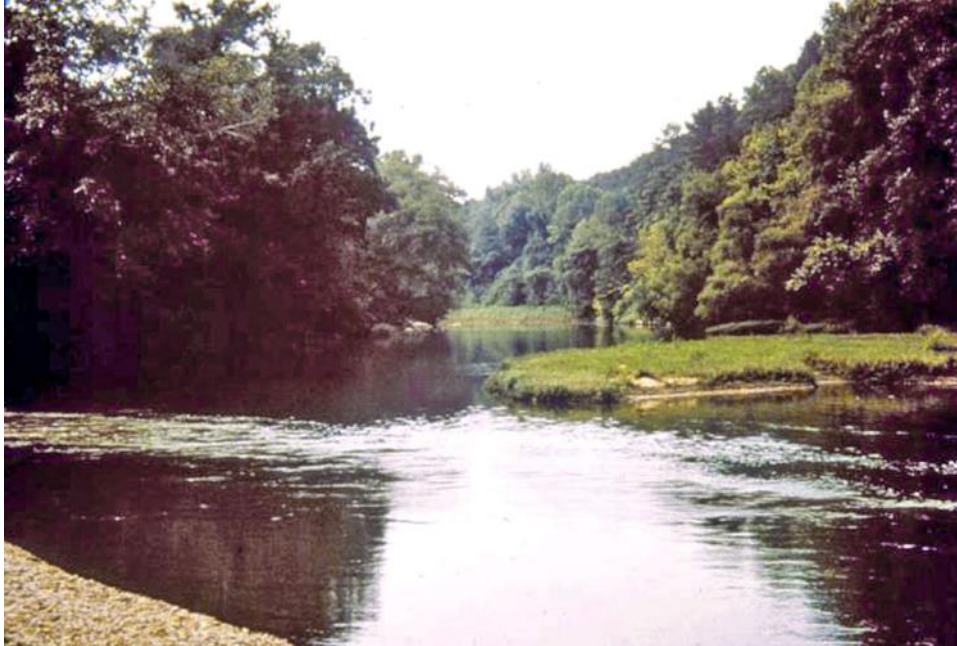
Figure 311. Buttahatchee River before headcutting. Picture (slide: Image 2027) was taken by Paul Hartfield.

Buttahatchee River. The Buttahatchee River is a major tributary of the Tombigbee River in northeastern Mississippi. It supports 37 species of mussels, four of which are federally listed. In the 1970s, the Tennessee-Tombigbee Waterway was constructed, and gravel mines were established near the mouth of the river. Pre- and post-waterway surveys documented a 95% decline in mussel abundance and a 60% decline in mussel diversity in the lower portions of the river. **Figures 311-312** show the Buttahatchee River before and after headcutting upstream from gravel mining operations. **Figures 313-314** show flooded gravel pits along the course of the Buttahatchee River at Hamilton, Mississippi.

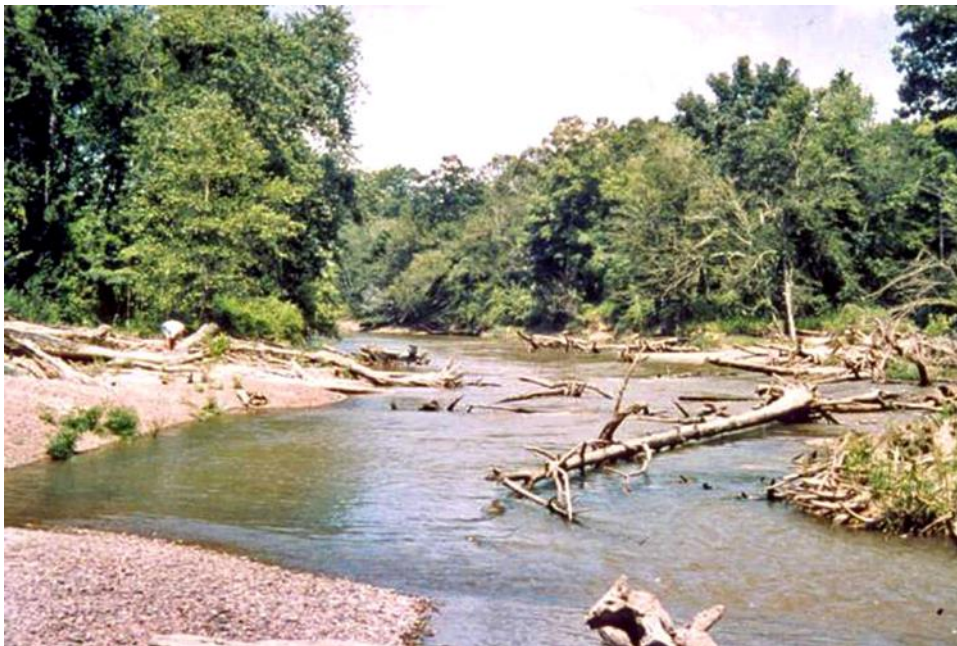
Figure 312. Buttahatchee River after headcutting in 1988. Picture (slide; Image 2028) was taken by Paul Harfield in 1988.
